ENVIRONMENTAL STEWARDSHIP SUMMARY REPORT

OF THE CONSTRUCTION, OPERATION, AND MAINTENANCE OF TACTICAL INFRASTRUCTURE PEDESTRIAN FENCE SEGMENTS D-5B, D-6, AND E-2A U.S. Border Patrol Tucson Sector, Arizona

U.S. Department of Homeland Security
U.S. Customs and Border Protection
U.S. Border Patrol

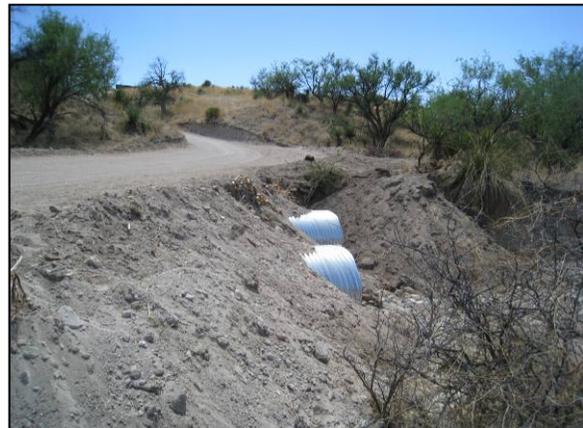
Photograph 3-1. New Access Road with Culverts

Six cattle guards were installed on the access roads. This construction was not addressed in the ESP, but the change was documented in an approved CR. In addition, the ESP did not address improvement of preexisting access roads, but the survey noted that portions of the roads were regraded to smooth out eroded spots (Photograph 3-2). It also noted that culverts were installed on the new access road (see Photograph 3-1).

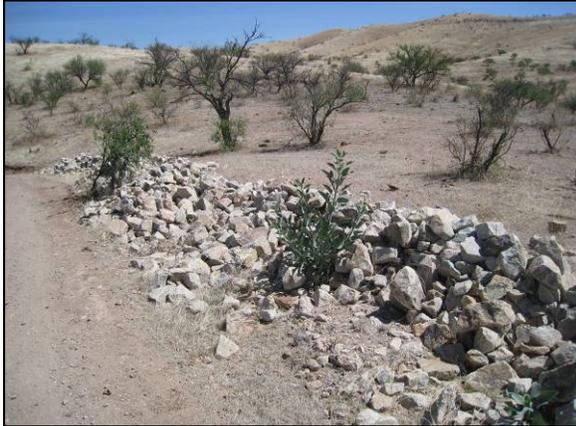
Photograph 3-3. Rock Piles on Side of Access Road

On Royal Road, several piles of rock from grading and leveling activities were adjacent to the road in two separate locations (Photograph 3-3). The survey revealed two realignments of this road for 0.9 mile near the southern end where it connects to the fence maintenance road. There was also an 8-foot-wide disturbance where an all-terrain vehicle (ATV) trail cut through a switchback (Photograph 3-4) and one cattle guard was installed.

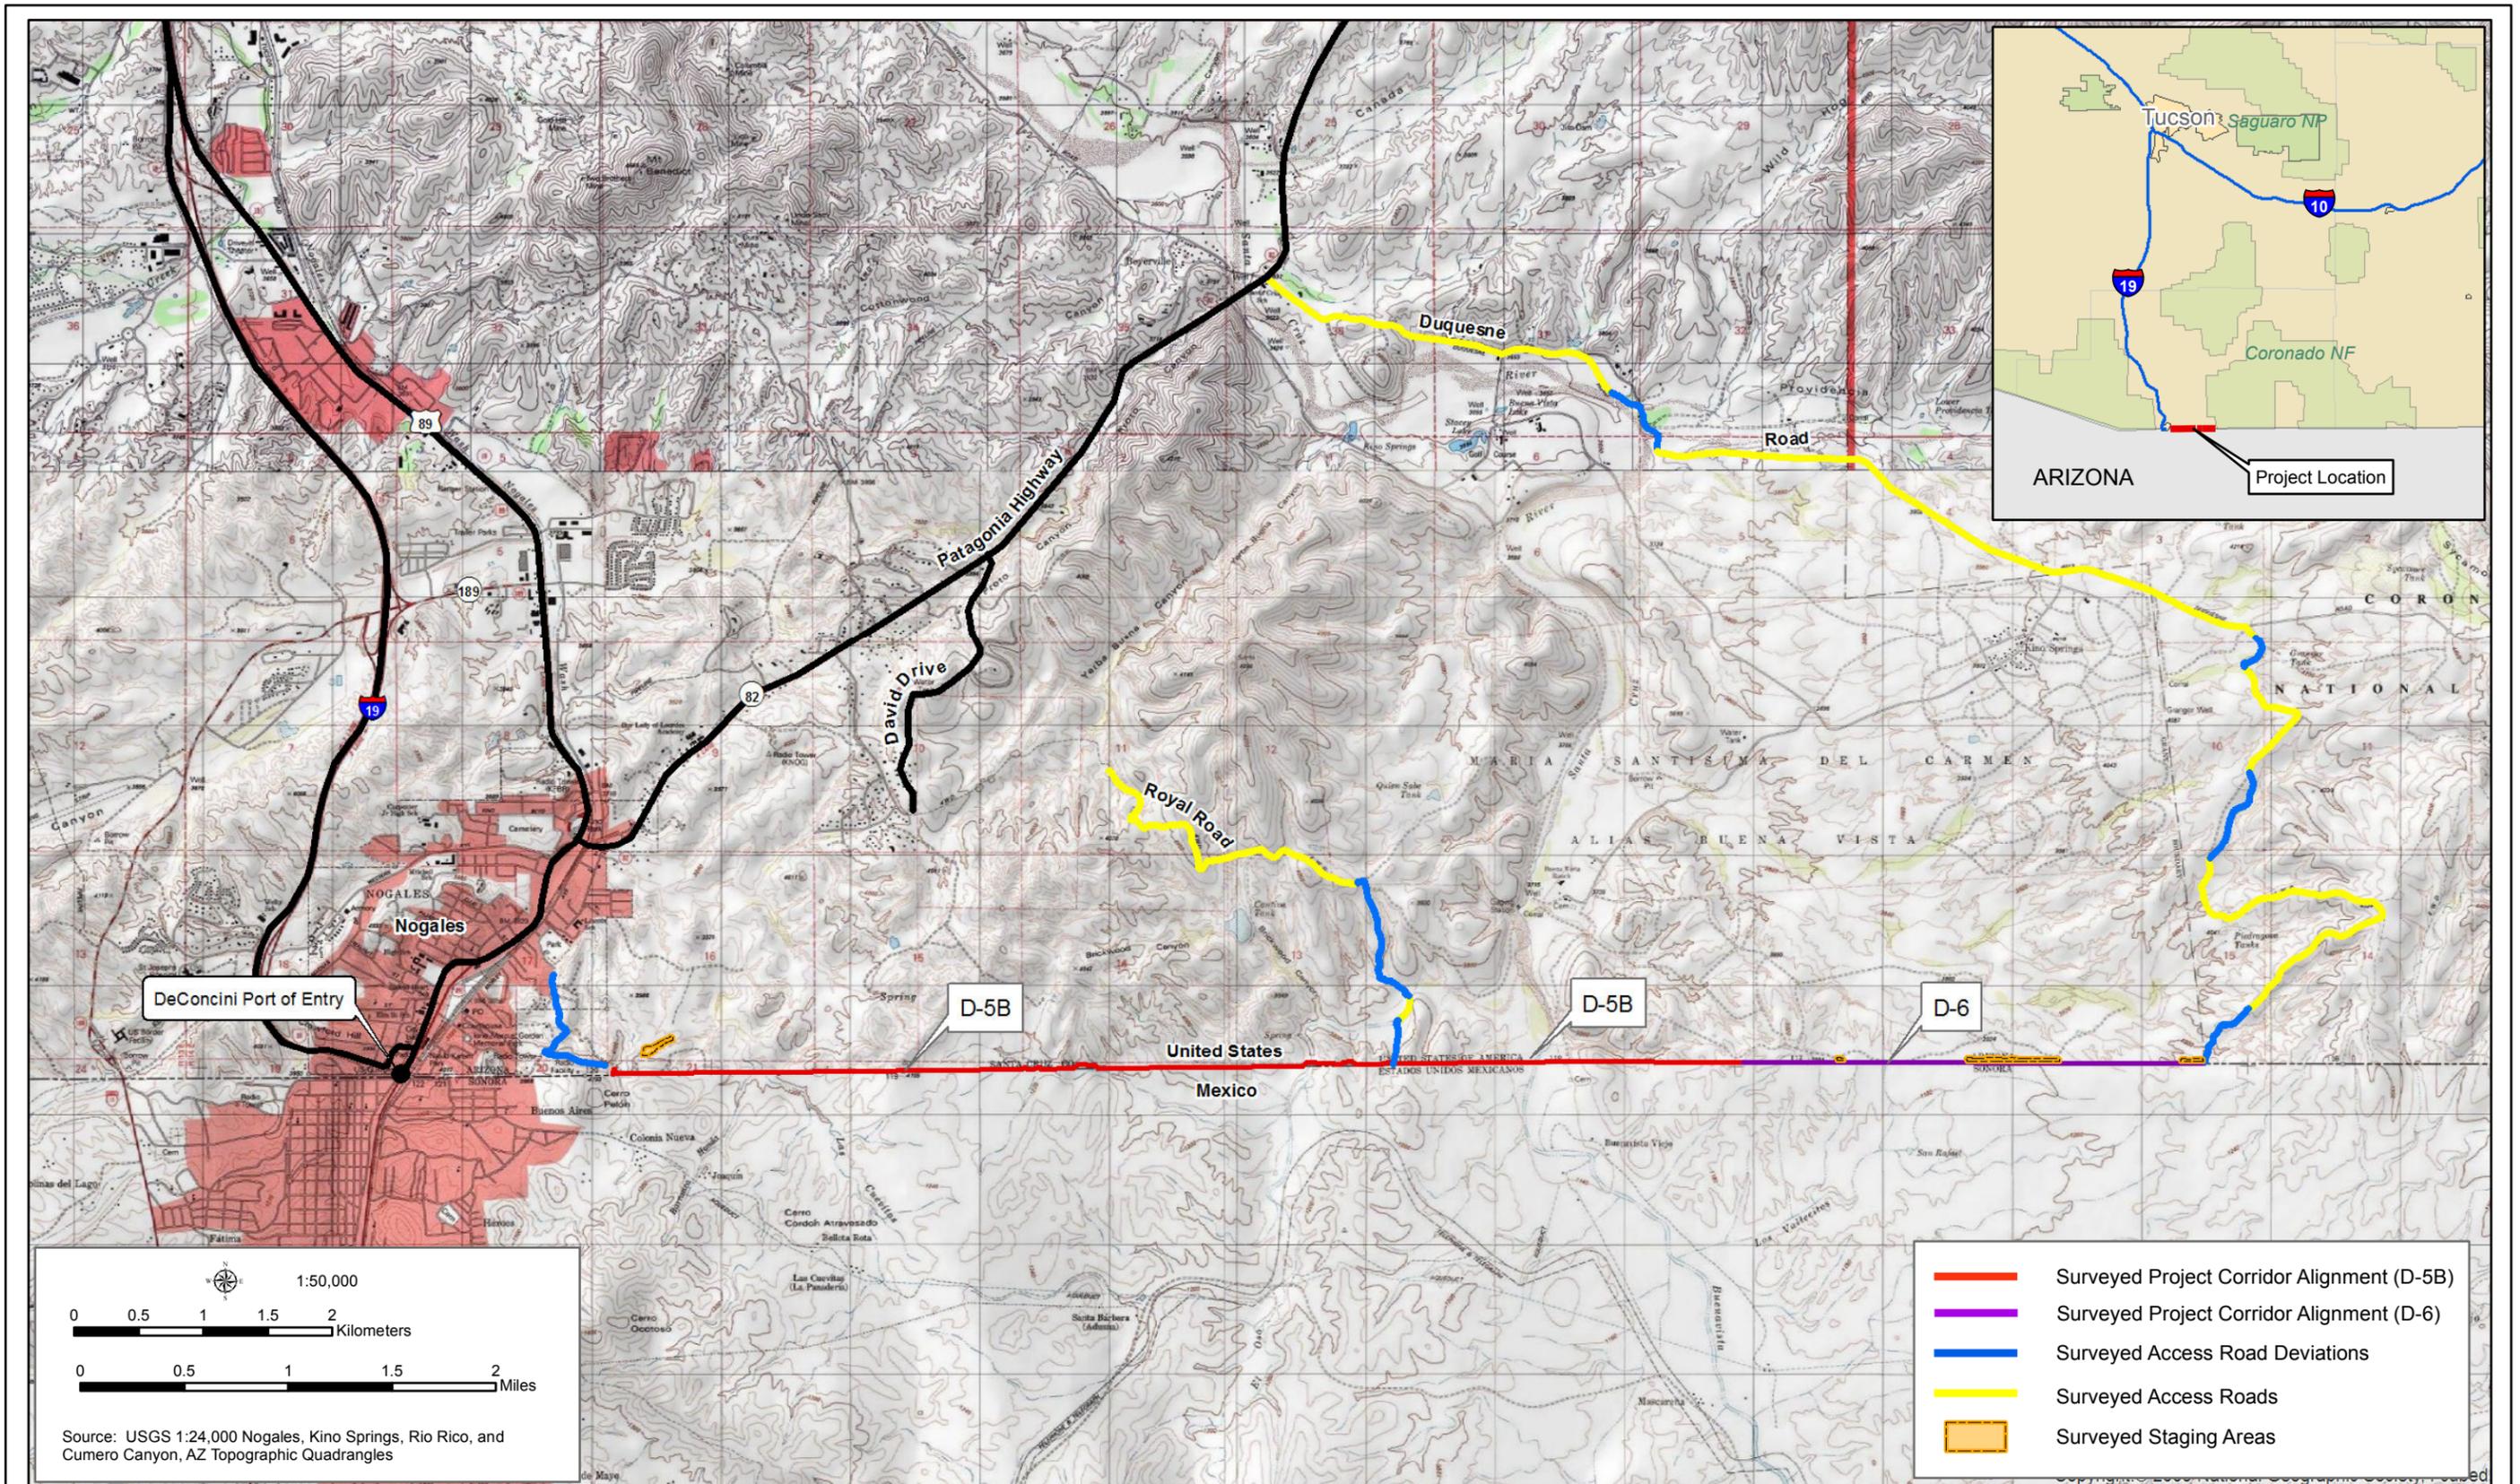
Figure 3-1: D-5B and D-6 Post-Construction Project Infrastructure

The ESP reported that an access road for D-5B and D-6 would be built on the northern side of the fence. The length of the construction footprint was expected to be 7.6 miles and encompass a 60- to 70-foot-wide corridor, depending on the topography at the U.S./Mexico international border. The post-construction survey revealed that the maintenance road was 7.6 miles long. The western terminus of the D-5B project corridor extended 178 feet west of what was presented in the ESP, and the eastern terminus of the D-6 project corridor was approximately 78 feet

shorter than was presented in the ESP. This slight difference is expected during normal construction activities. The survey recorded an actual maximum corridor width of 125 feet, so the planned project corridor width was not exceeded.

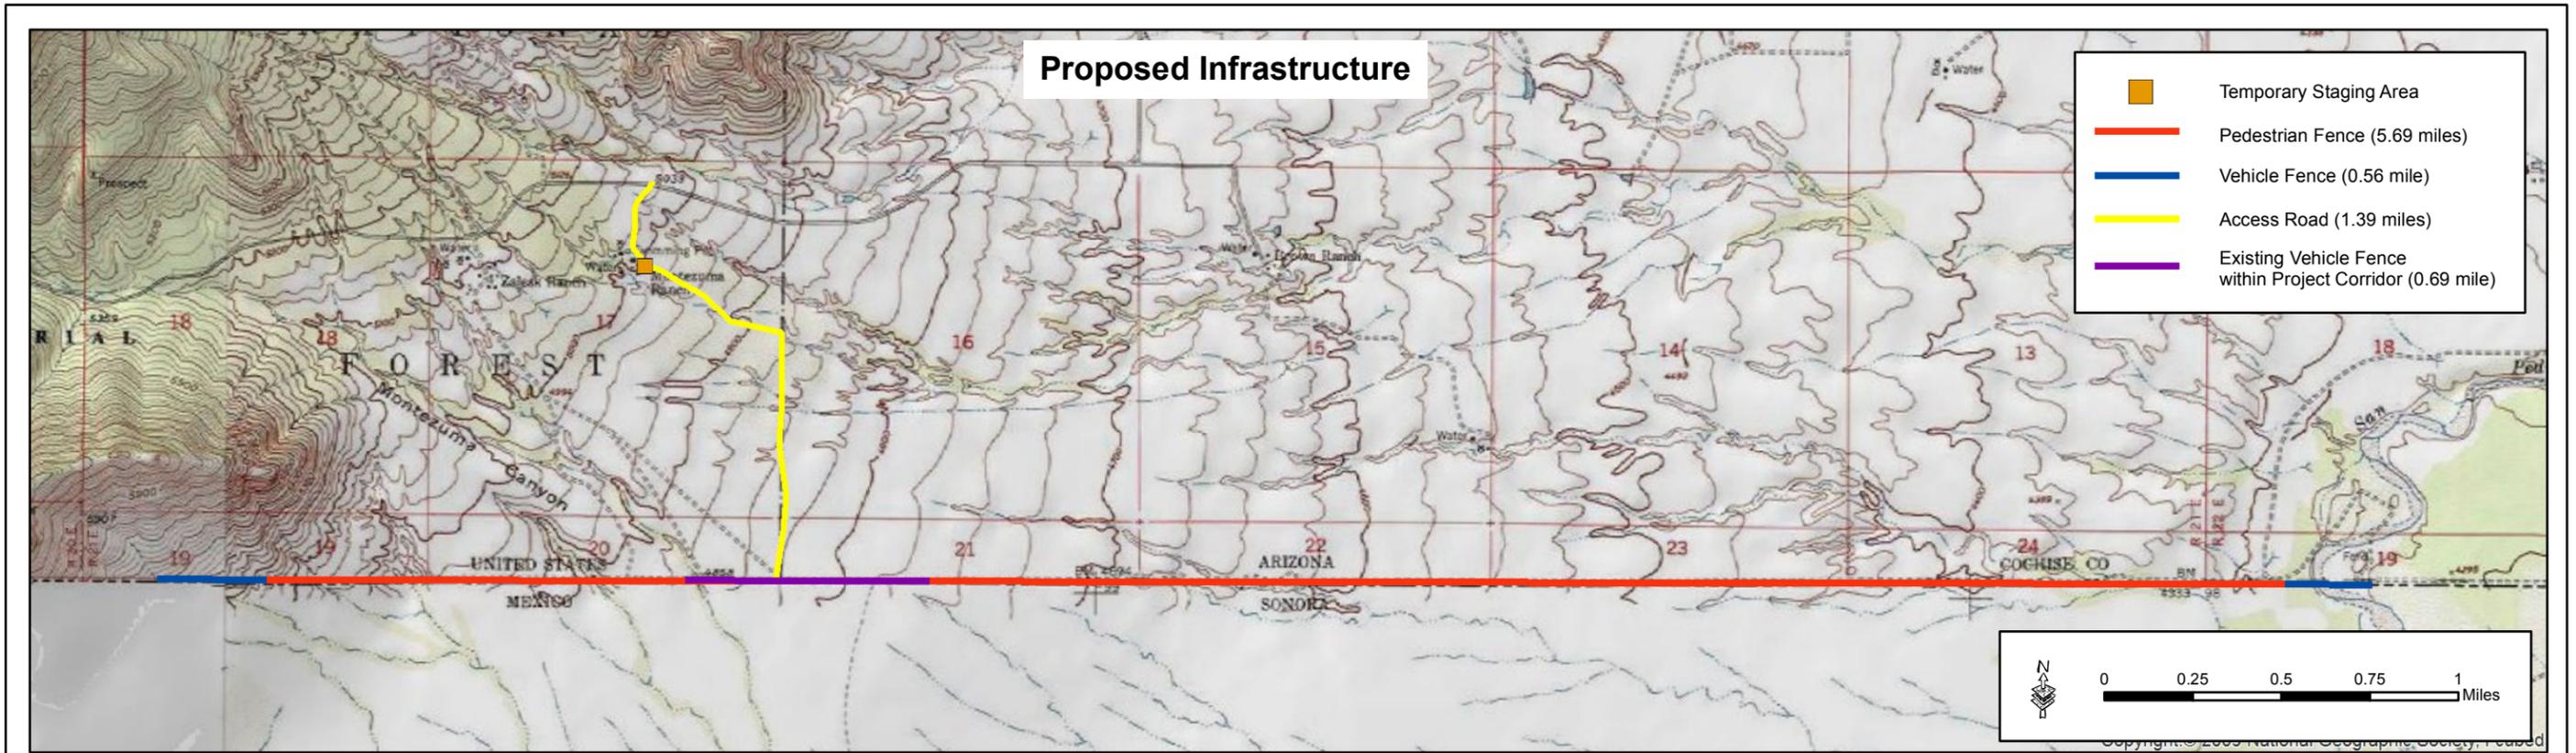
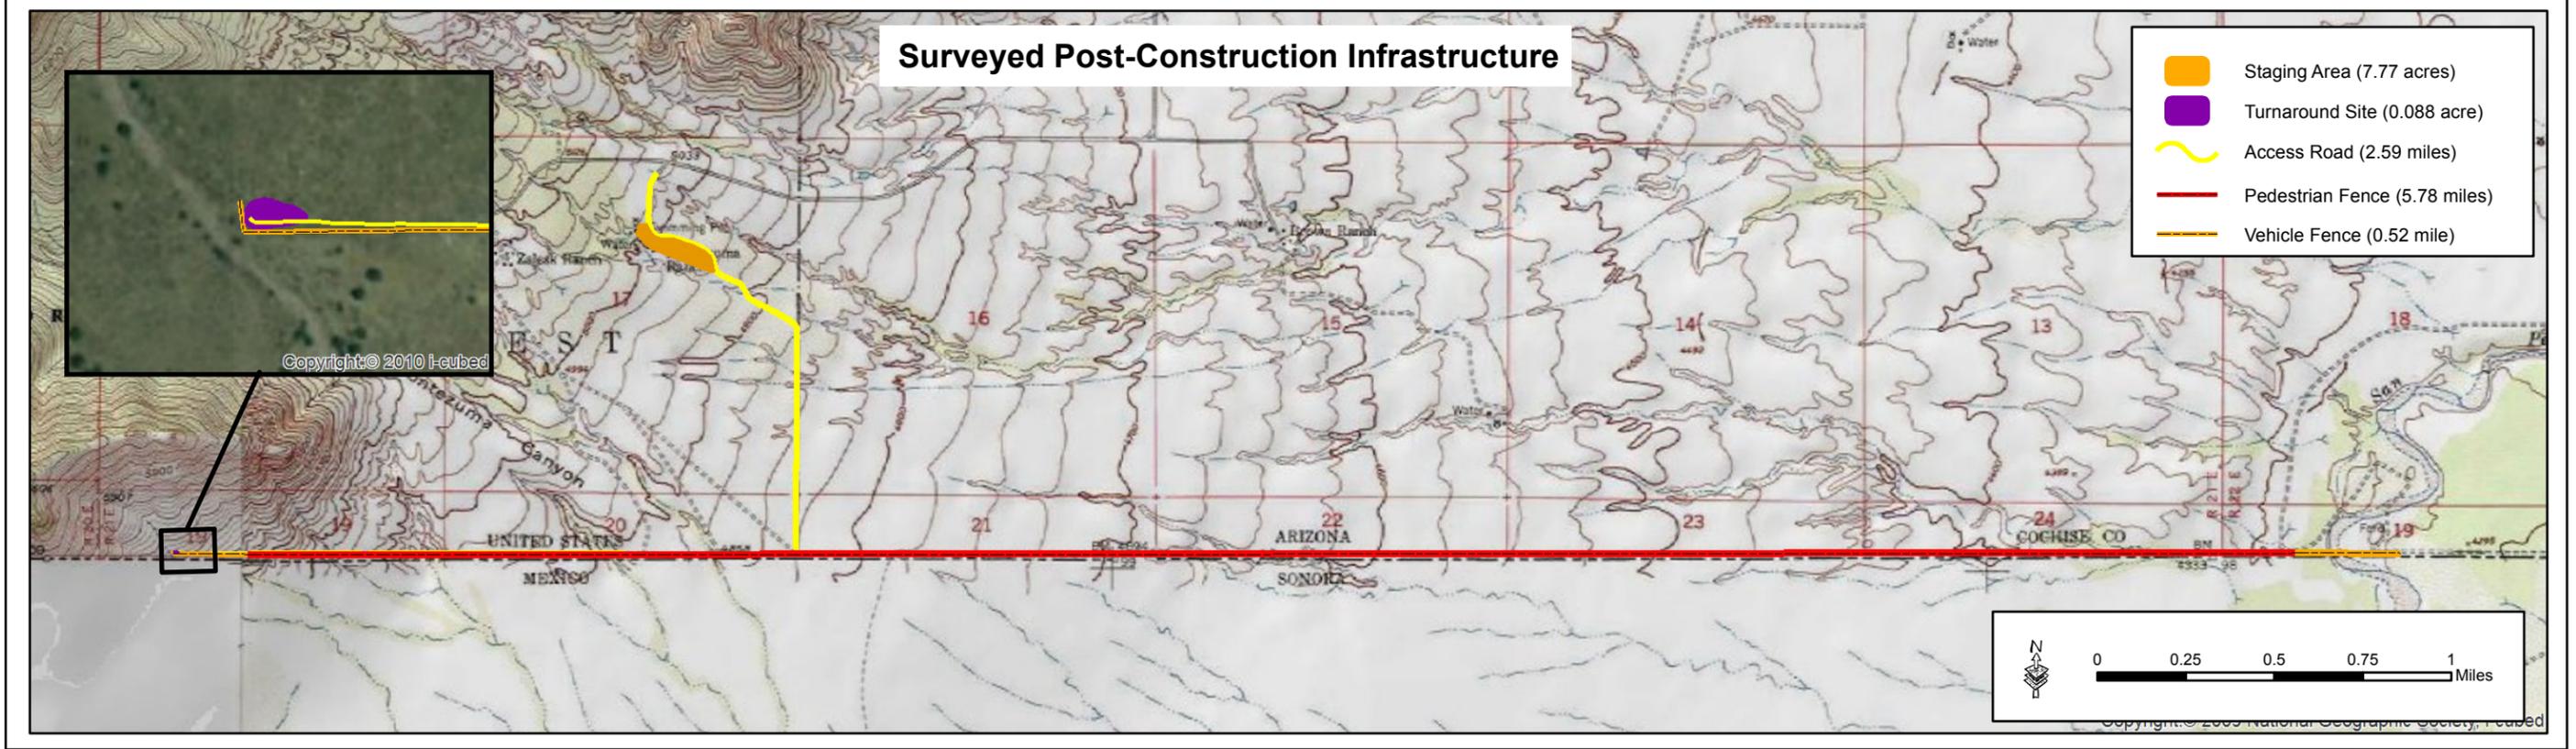
Figure 3-2: Planned versus Implemented Infrastructure of E-2A

Additionally, the area outside the 16-foot disturbance has been reseeded with native vegetation. Figure 3-2 presents a map of the ESP planned access road corridor and the post-construction surveyed access road. Although the ESP stated that the road would be 1.30 miles long, the survey determined that its length was 1.32 miles, thereby increasing the permanent project footprint by 0.03 acre.

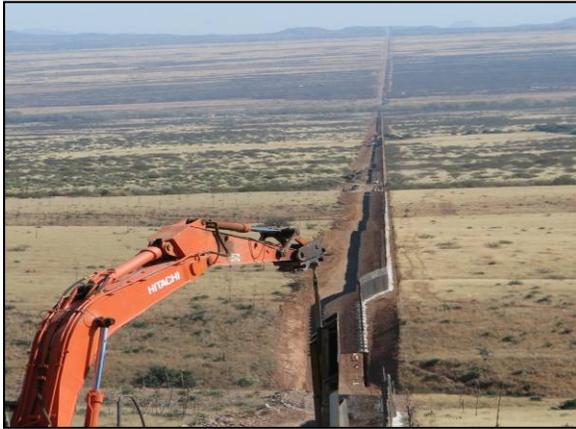
Photograph 3-5. Width of Maintenance and Patrol Road Project Corridor Is 50 Feet along Entire Length of E-2A

With the exception of a turnaround site in the western section of the project corridor, the width of the access road footprint did not exceed 50 feet (Photograph 3-5). The ESP assumed the project corridor width would be 60 feet wide and up to 250 feet wide in large washes. The reduction of the width of the project corridor reduced the project footprint by 7.2 acres.

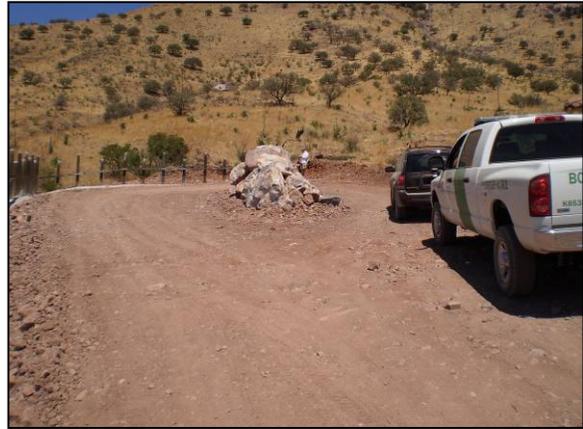
Photograph 3-6. Turnaround Site on the Western Terminus of E-2A

At the turnaround site, approximately 0.03 acre of maintenance/patrol road is located outside the planned project corridor (Photograph 3-6).

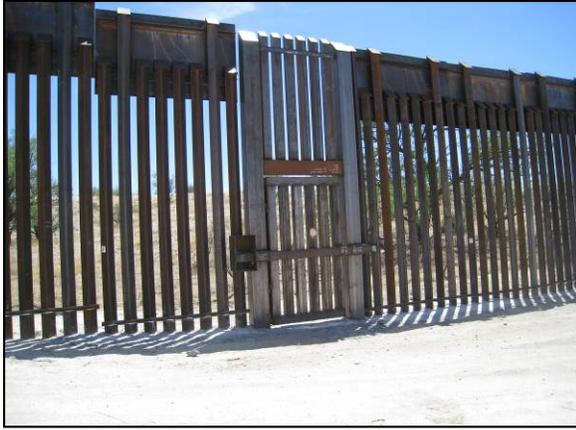
Photograph 3-7. Bollard Fence (PV-1) Including Access Gate

The ESP for the D-5B and D-6 project corridor reported that two types of fence would be installed. The post-construction survey confirmed installation of the two types of fences, bollard fence (PV-1) and Normandy-style vehicle fence (VF-2) (Photographs 3-7 and 3-8). According to the ESP, segment D-5B was to be 5.2 miles long and D-6 2.4 miles long. However, the length of each segment changed slightly during construction. A CR refined the approved measurements to 5.27 miles for D-5B and 2.23 miles for D-6. The post-construction survey measured the length of each type of PV-1 and VF-2 fence and found that for the D-5B and D-6 project corridor 7.4 miles of PV-1 and 0.18 mile of VF-2 fence were installed, respectively. There was also a 75-foot-long segment within the Santa Cruz River where fencing was not installed. Table 3-1 compares the planned and surveyed lengths of fence for D-5B and D-6.

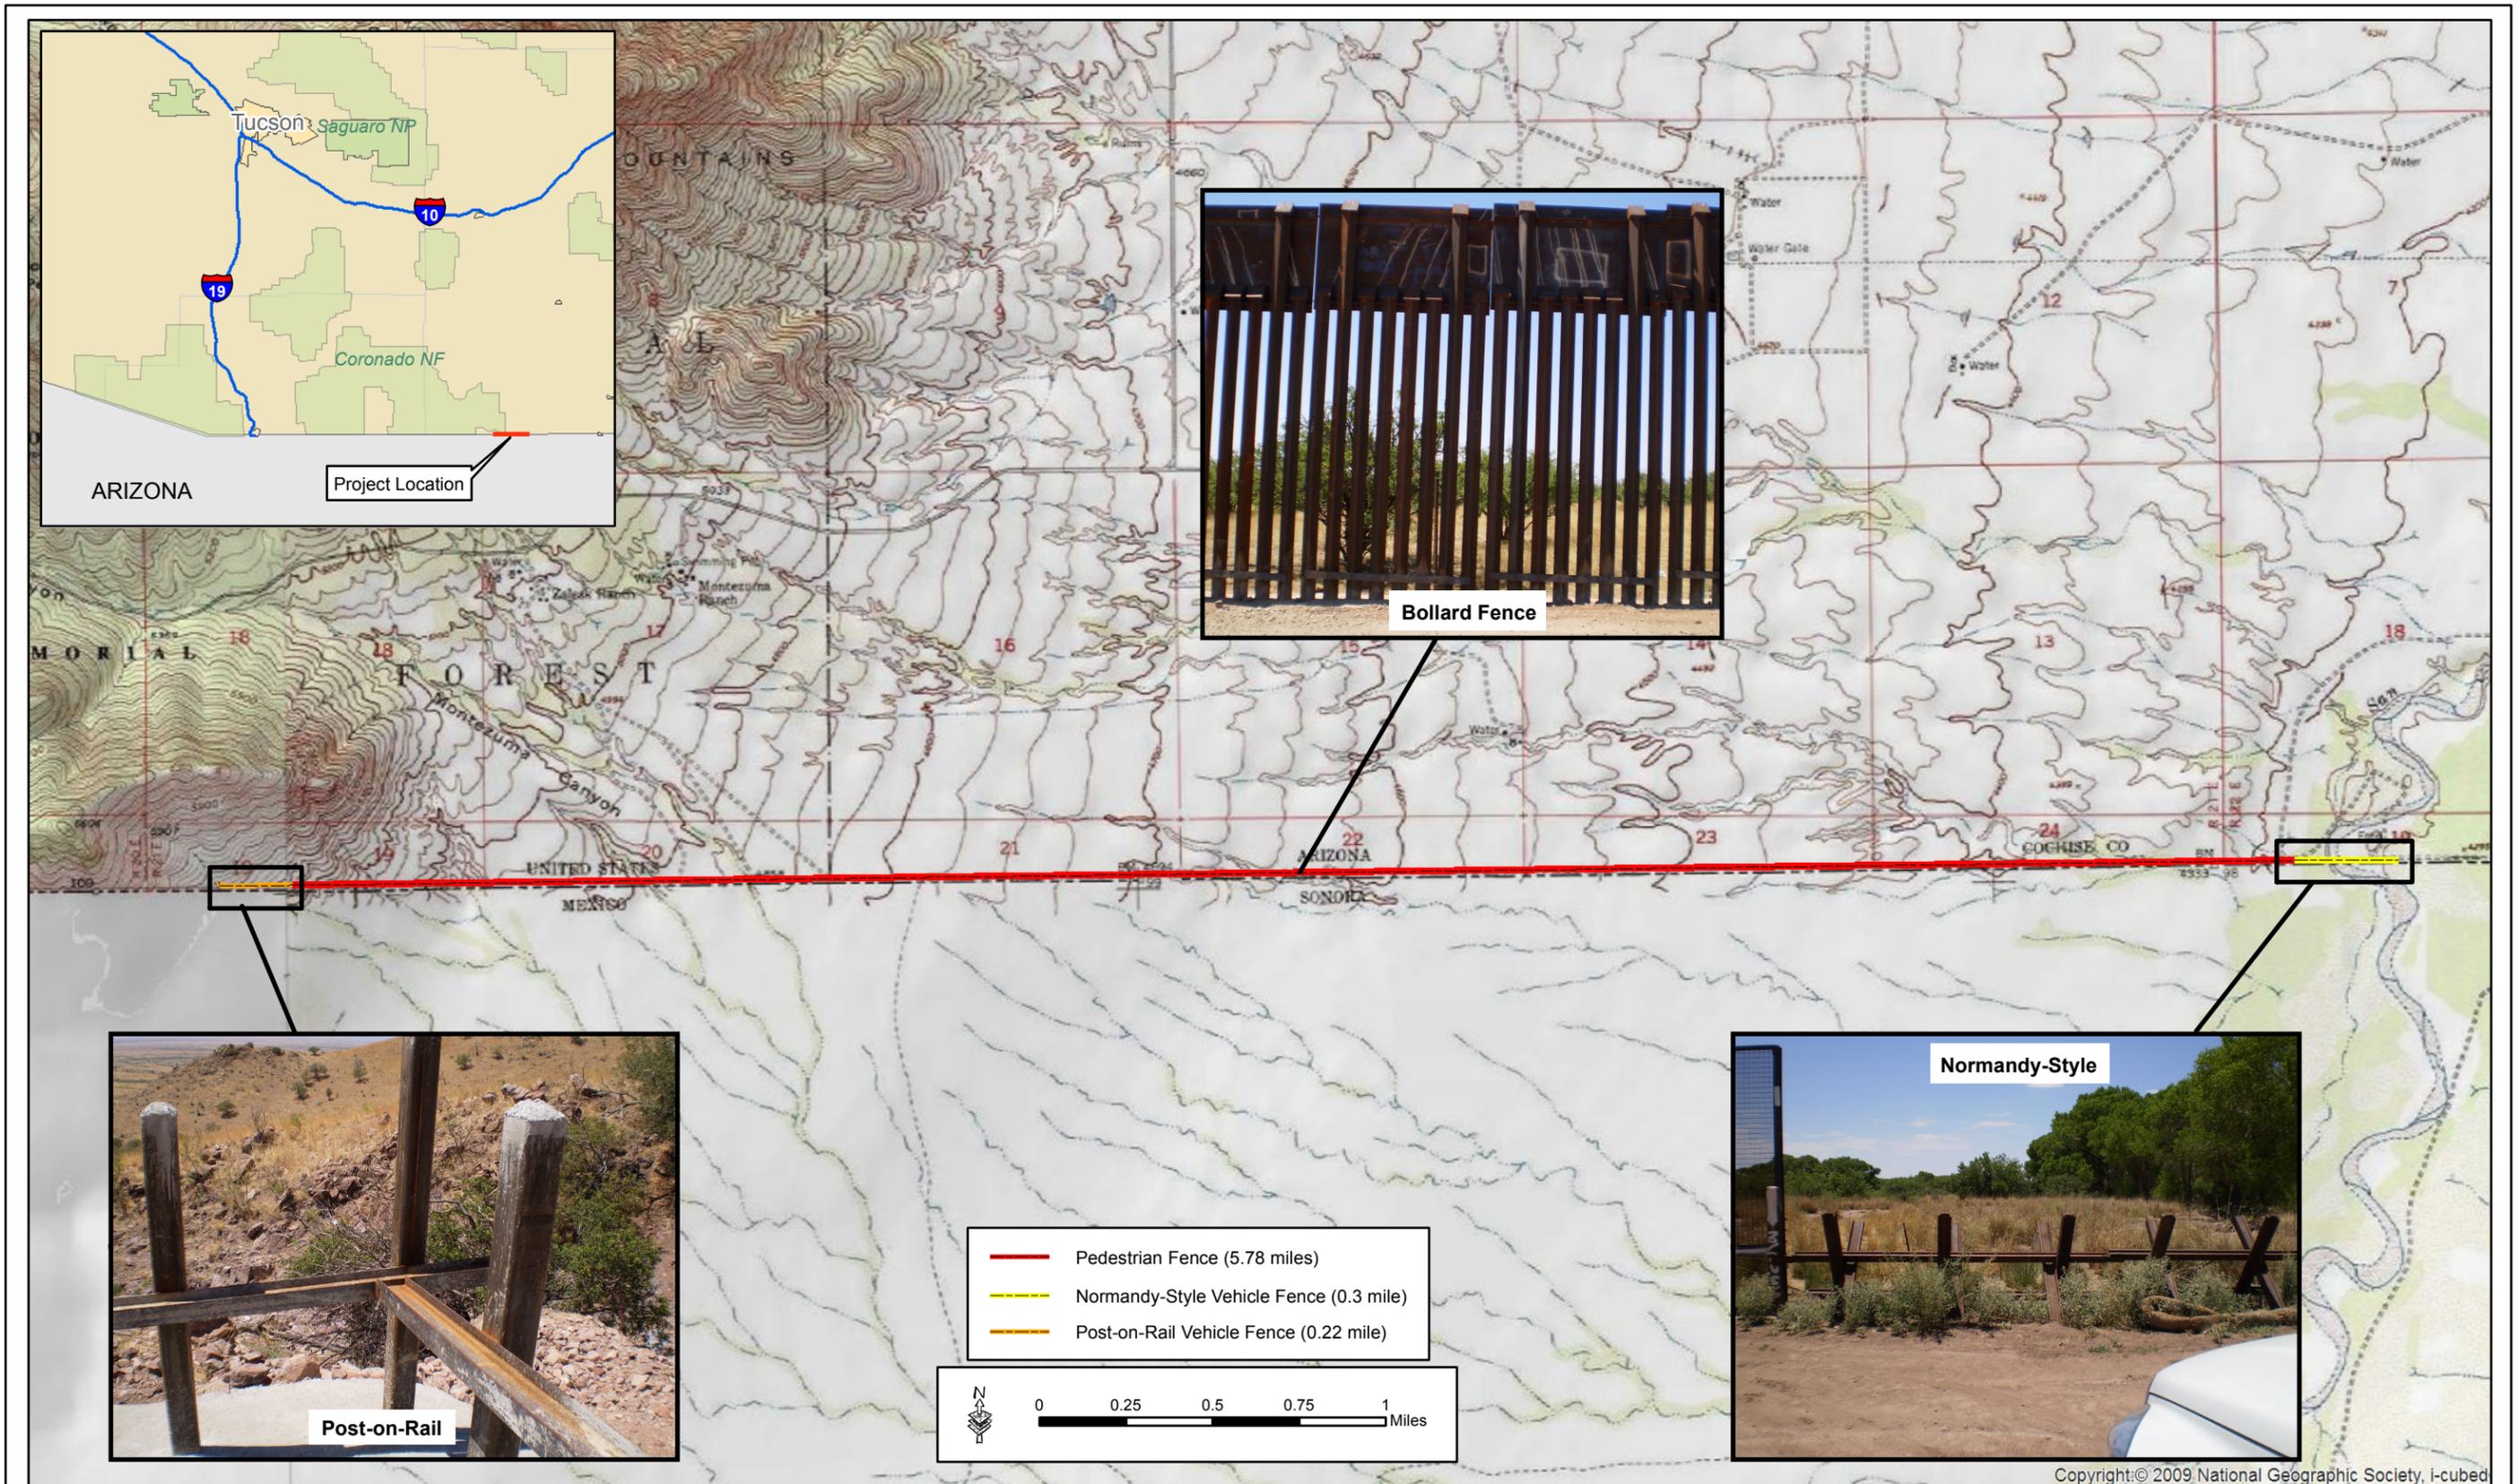
Figure 3-3: Types of Fence Installed in Section E-2A

The ESP reported that two types of fence would be installed in the E-2A project corridor. The post-construction site survey found that three types of fences were used: bollard fence (PV-1), Normandy-style vehicle fence (VF-2), and post-on-rail vehicle fence (VF-1). The ESP stated that a Normandy-style vehicle fence would be installed for 0.18 mile on the eastern end and 0.31 mile on the western end. As mentioned above, two types of vehicle fence were installed. The Normandy vehicle fence was installed on the eastern end for 0.30 mile, and post-on-rail vehicle fence was used for 0.22 mile on the western end. This modification to fence style did not change the project footprint or affect the natural environment, and was noted in an approved CR.

The length of fence changed slightly. The post-on-rail vehicle fence, on the western terminus, turns 90 degrees to the north for 60 feet along the bank of a wash (see Photograph 3-6). The 60-foot extension to the north prevents vehicles from driving down the wash, around the end of the fence, and up the bank to access the patrol road. Figure 3-3 is a map depicting the location of the three types of fence and fence extension on the western terminus of E-2A. Table 3-2 compares the planned and surveyed lengths of fence for E-2A.

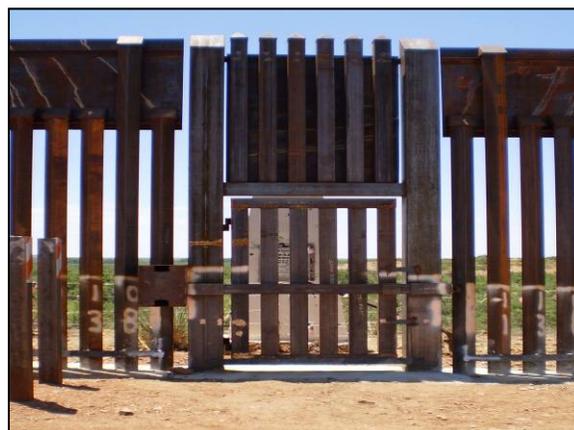
Photograph 3-9. Access Gate to Border Monument
98

A cultural site was discovered during construction of the new access road to the D-6 segment. Construction was halted, and the road was realigned to avoid the site. This realignment was authorized by a CR. No new cultural resources were discovered in the E-2A segment during construction or within the areas added during the modification to the staging area and access road. Gates were installed along the E-2A project corridor adjacent to border monuments, which are approximately 4 feet south of the fence. This will provide the USIBWC with access and space to repair and maintain the monuments (Photograph 3-9).

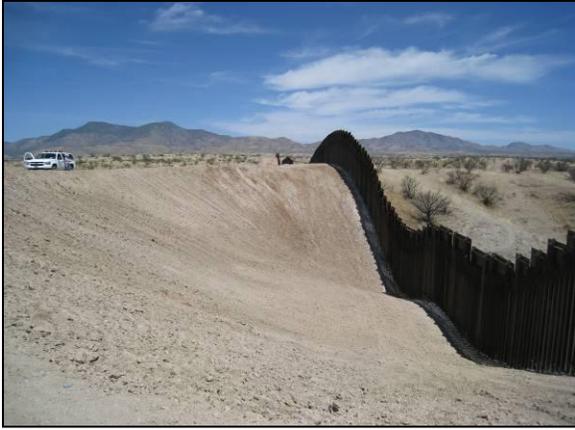
Photograph 4-1. Large Areas of Exposed Soil

The D-5B and D-6 post-construction survey identified one additional issue that requires consideration. Large areas of exposed soil (Photograph 4-1) and erosion problems were noted along the fence and maintenance road corridor, as well as the access roads, especially Royal Road (Photograph 4-2). CBP has implemented a Comprehensive Tactical Infrastructure Maintenance and Repair (CTIMR) program to ensure the fence and related roads are maintained long-term.
